4. Air pollution and damages to the cultural heritage in cities

The decay of the cultural heritage of Kraków

Wanda Wilczyńska-Michalik

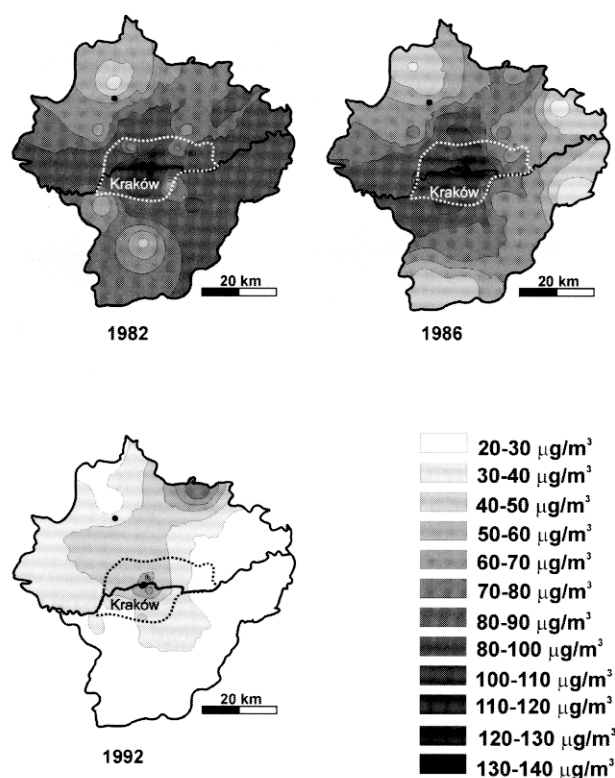
Figure 4.4 The average annual concentration of suspended dust (particles below $10 \mu\text{m}$ of diameter) in Krakowskie voivodeship during the period 1982-1992. According to data of the Voivodeship Inspectorate For Environmental Protection in Kraków, 1994.

The highest average levels of annual concentration of suspended dust and sulphur dioxide were noted in the city centre in the period 1968 to 1987, when sulphur dioxide concentrations varied from 83 in 1971, to 122 $\mu\text{g}/\text{m}^3$ in 1985, and concentration of suspended dust varied from 143 in 1977 to 195 $\mu\text{g}/\text{m}^3$ in 1972 (Lach et al. 1996). The average annual concentration of sulphur dioxide in the city centre varied from 122 in 1985 to 75 $\mu\text{g}/\text{m}^3$ in 1990 and 1992 (Figure 4.3), and the average annual concentration of suspended dust particles of diameter below 10 μm varied from 116 in 1986 to 52 $\mu\text{g}/\text{m}^3$ in 1992 (Figure 4.4).

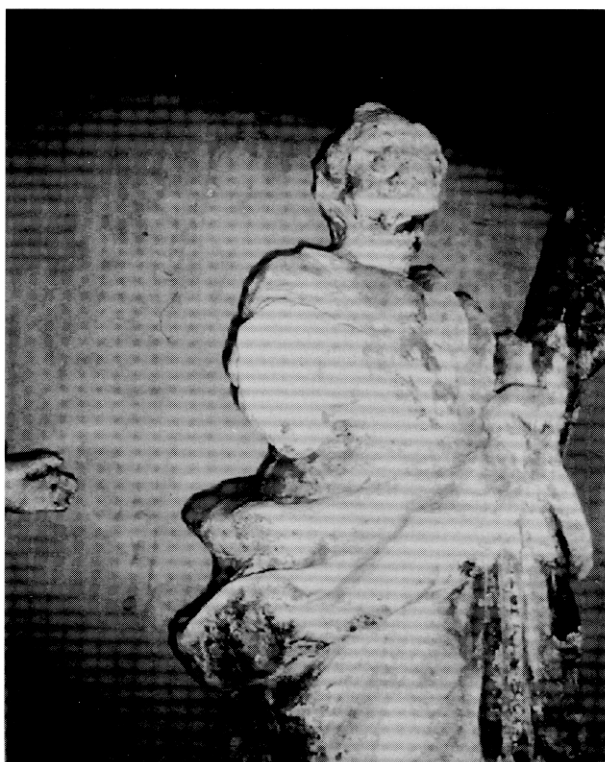
Figure 4.8 The strongly damaged sculptures of the Apostles from the 18th century. Photo: Wanda Wilczynska-Michalik.

The sculptures in of the Apostles from the 18th century, made in Pinczów limestone, were badly blackened and in an advanced stage of decay (Figure 4.8). Some of the badly disintegrated carved elements could not be recognised, and material and stone fragments from surface and subsurface layers of the Pinczów limestone had crumbled. Gypsum crystals had formed under the surfaces layers of the lime-

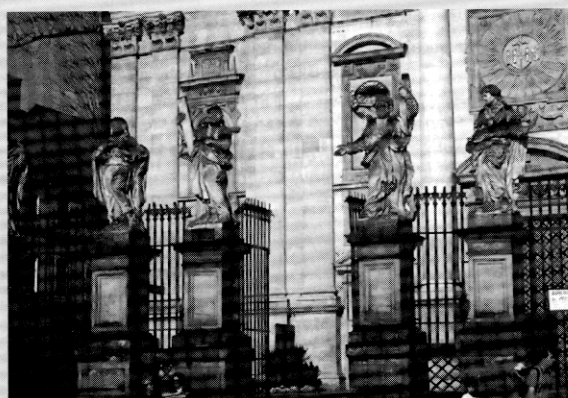
Figure 4.11 The fence of the church of Saints Peter and Paul with the sculptures of the Apostles. Photo: Wanda Wilczynska-Michalik.

The Church of Saints Peter and Paul (built at the beginning of the 17th century) is considered to be one of the most magnificent early baroque churches in Central Europe. The fence topped with sculptures of the Apostles and enclosing the yard in front of the church is a very characteristic feature of this monument (See Figure 4.11).

The precise date of the installation of the sculptures of the Apostles has been a matter of speculation in the past and in reality we may never know the exact truth. However according to Karpowicz (1985), we can be reasonably confident that the sculptures that decorate the fence in front of the Saints Peter and Paul church are most likely from around 1715-1722. The 18th century sculptures were heavily decayed and now are replaced by copies.

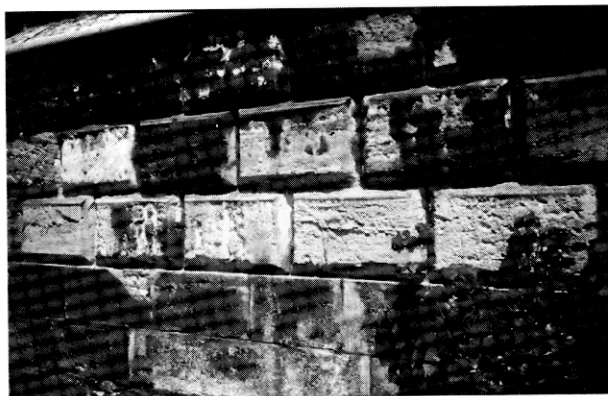
Figure 4.12 An alveolar pattern underneath a thin gypsum crust. Libiąż dolomite. The walls surrounding Wawel Cathedral.

The Libiąż dolomite in the historical architecture in Kraków has decayed rapidly during the last fifty years. On the wall surrounding the Wawel Cathedral, the portal of the external gate of the Royal Sarcophagus and the front façade of the Church of Saints Peter and Paul, were 1-30 cm² alveolar cavities from 1-4 cm deep (Figures 4.12, 4.13).

The damaged rock surfaces were carefully examined. The cavities were soft, crumbly and scaly. Assemblages of magnesium sulphate hexahydrate, epsomite (i.e. magnesium sulphate heptahydrate) and gypsum (calcium sulphate dihydrate) occurred as 100-500 µm thick discontinuous encrustation. Considerable amounts of salts were concentrated at the bottom of the gradually eroded cavities, where they were protected against washing rain. Part of the exterior surface of the dolomite stone was covered with a dark crust of minute needle-like gypsum crystals including large amounts of up to 60 µm large dusts particles.

Cavernous and honeycomb weathering (alveolar patterns) was characteristic of the surfaces exposed to rain and wind action. The porosity (7% to 12%) and imbibition (2.3% to 5.6%) of the dolomite permits moderate to good moisture penetration. The movement of ions from the rock dissolved by rainwater towards the stone surface and ions from rainwater into the rock, and cementation of pores by precipitated and crystallized soluble salts, fundamentally alter the properties of the surface layer of the stone compared with those at depth. This is probably the main reason of alveolar pattern development. As wind speeds up the evaporation of water the soluble salts crystallises.

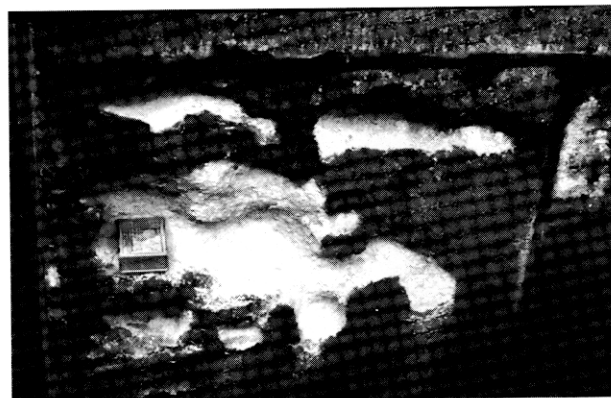
Figure 4.13 Honeycomb weathering of the front façade of the Church of Saints Peter and Paul. Libiąż dolomite.

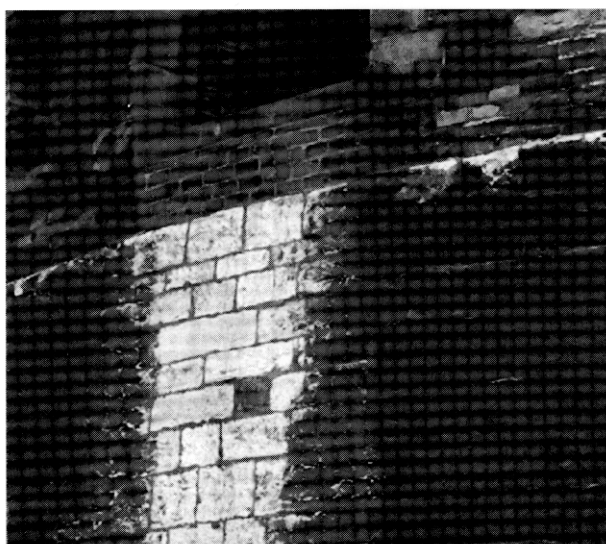
Figure 4.16 Strongly contrasted white (exposed to running rainwater) and dark (protected from direct rainfall) surfaces. The Upper Jurassic limestone. 19th century Wawel fortification.

The Jurassic limestone in Wawel's fortification walls from the 19th century, have contrasting black and white zones (Figure 4.16). The white zones develop on surfaces exposed to rains, which washes out airborne pollutants and initiates formation of a crust of gypsum on the surface. The gypsum crust is not stable; solutions migrate freely into the limestone. Here the gypsum repeatedly dissolves and recrystallises in the alternating episodes of wetness and dryness of the stone, and causes mechanical stresses in pores and cracks.

The intensive blackening was typical of humid surfaces exposed to the north. Also here gypsum crust forms. The surface of a black gypsum crust is uneven, from 0.3 to 10 mm thick, with subparallel folds or mushroom-shaped forms. Polarising microscopes and scanning electron microscope pictures show that the darkening is caused by black fly ash particles (Figure 4.17), but it probably also comes from microorganisms, such as cyanobacteria. Their role in weathering of limestone surfaces, often re-

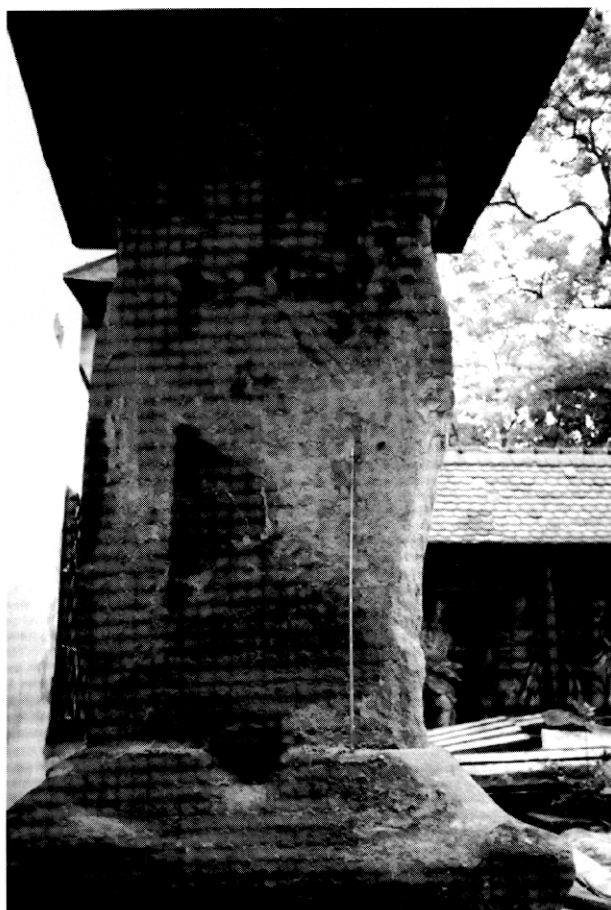
Figure 4.20 The later stages of weathering of old sandstone bases, manifested as disintegration, exfoliation, crumbling, and rounding of edges. Church of Saints Peter and Paul. Photo: Wanda Wilczynska-Michalik.

The later stages of weathering of the bases described here, has been manifested as disintegration, exfoliation, crumbling, and rounding of edges (Figure 4.20). Together with the detached gypsum crust some components of sandstone are removed from the rock surface.

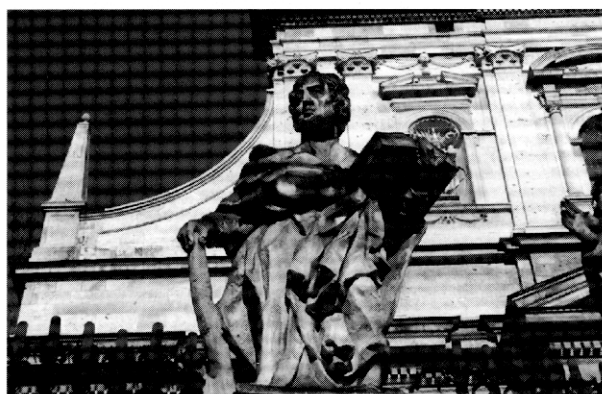
Figure 4.22 The façade of the Church of Saints Peter and Paul after renovation. New copies of the statues of the Apostles carved in the 1980s. The blackening of surfaces. Pińczów limestone. Photo: Wanda Wilczynska-Michalik.

The Libiaż dolomite on the wall surrounding the Wawel Cathedral, the portal of the external gate of the Royal Sarcophagus and the front façade of the Church of Saints Peter and Paul have now been restored to their unweathered appearance. The 18th century sculptures of the Apostles that decorate the fence in front of the Saints Peter and Paul church, which were heavily decayed, were replaced by copies in the 1980s. After about twenty years of exposure, blackening of the surfaces can be noticed on the new statues (Figure 4.22).

The bases of the sculptures, made in Carpathian flysch sandstone which is especially sensitivity to pollution, were badly damaged. New bases, made in a different type of sandstone, replaced the original ones in 1980s. The copies of the statues of the Apostles, which are now on view, are placed on these new bases. The Cathedral has through these measures regained much of its former magnificence.
